SUMMARY OF FINDINGS: Jetty, Wilson's Beach

The Heritage Studio Limited was commissioned by Remuera Heritage to undertake high-level research to gain an understanding about the history of the jetty located at Wilson's Beach, Remuera. For some time, it has been the understanding locally that the jetty was built by a nearby resident prior to his death in 1900. The principal aim of the study therefore was to establish whether evidence exists to confirm the date of the existing jetty and whether in fact it pre-dates 1900.

Known locally as 'Wilson's Jetty', the structure is located on Wilson's Beach at the northern end of Victoria Avenue. Extending north into Hobson Bay, the jetty is a timber structure built on a series of piles, with a boardwalk edged by braced posts and rails. Currently, the jetty is inaccessible from the beach.

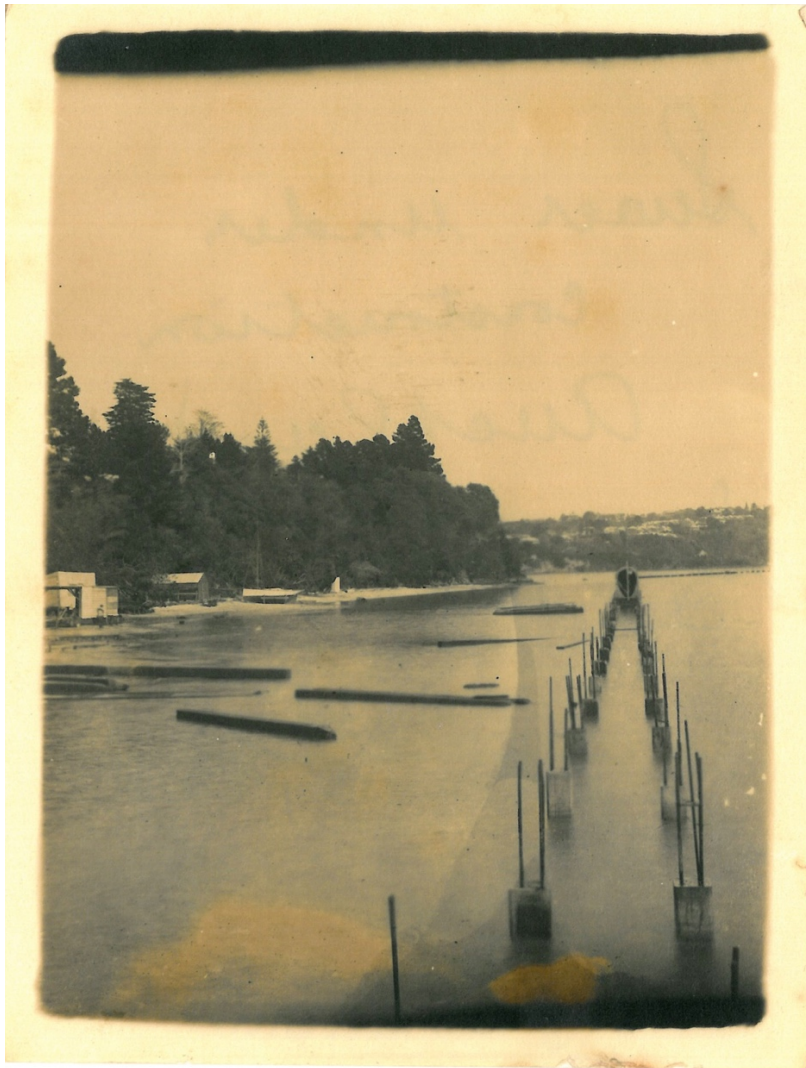
Figure 2: Photograph showing the main sewer line across Hobson Bay under construction, with Wilson's Beach to the left, c.1910-11. Note that there is no sign of the jetty at this time (Auckland Libraries Heritage Collections 1150-1).

Contemporary photographs of the construction of the Hobson Bay main sewer line in 1910-11 reveal that the existing jetty on Wilson's Beach was not in place at that time (Appendix 1, Figures 2 and 3). A newspaper article from 1913, however, documents a proposal for a 'wharf' at the foot of Victoria Avenue. The deputation from the Remuera Ratepayers' Association spoke of what an *"advantage a wharf would be to the whole district..."*⁶ (Appendix 2, Figure 13). The article goes on to explain that the wharf would connect the end of Victoria Avenue and the sewer from which it was proposed to start the wharf. However, the two proposed schemes sought the establishment of a 200ft long and 14 or 18ft wide bank, and a further 180ft wharf, which would suggest a structure more substantial than the one shown in early photographic records.

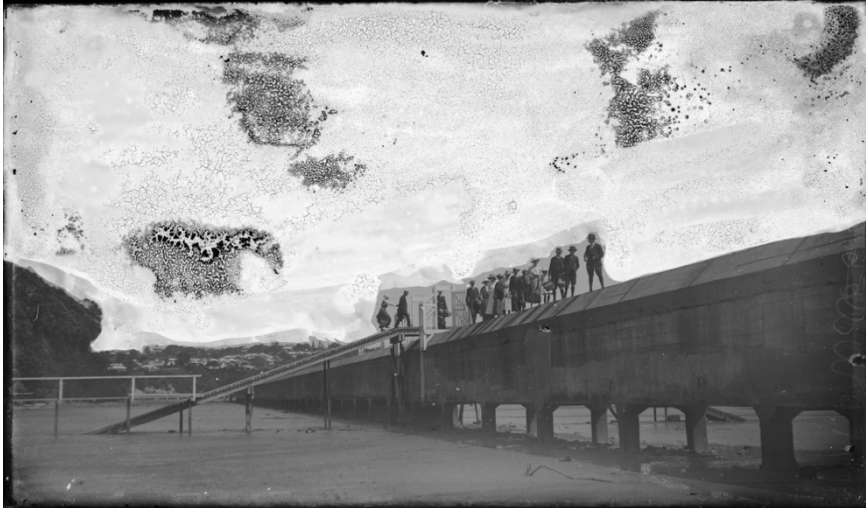
Figure 4: Photograph showing a group of people standing on top of the Hobson Bay sewer, date unknown. Note that the jetty has been constructed, which extends up and over the sewer (Auckland Libraries Heritage Collections, AHJ-G-191).

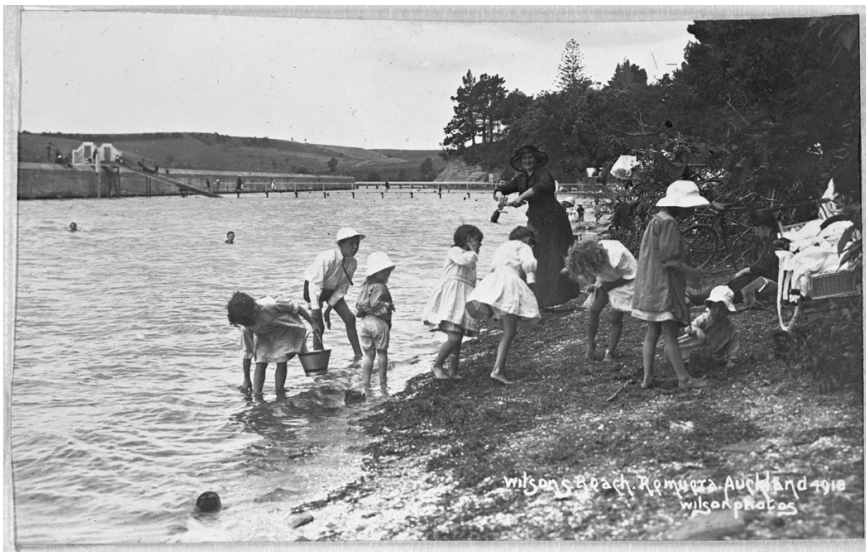
Figure 5: The first 'dated' photograph showing the jetty in the background and children on Wilsons Beach in the foreground, 1918 (Auckland Libraries Heritage Collections 7-A11230).

The earliest 'dated' photograph showing a jetty in the current location is from 1918 (Appendix 1, Figure 5), followed by several others dating from the 1920s and 1930s. These photographs show the jetty extending north from Wilson's Beach, up and over the sewer line, providing access into Hobson Bay. Some of these images also show people 'promenading' along the jetty and the sewer line.

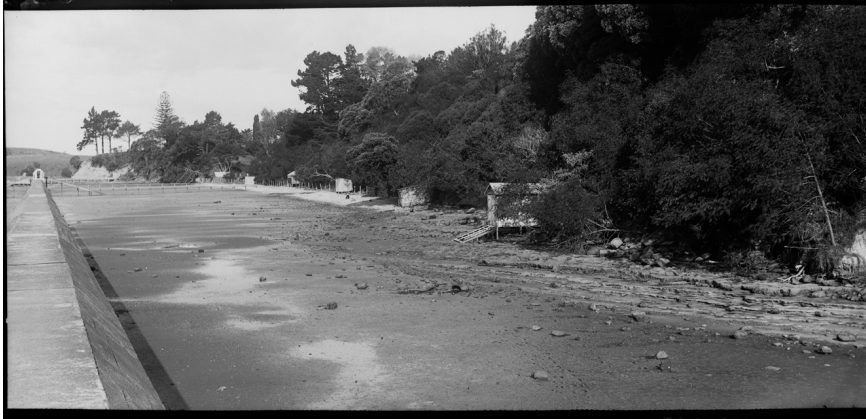
Figure 7: Looking east along Wilson's Beach showing the main sewer line and the jetty in the distance. Note also the boat and bathing sheds along the beach (Auckland Libraries Heritage Collections 4-5685).

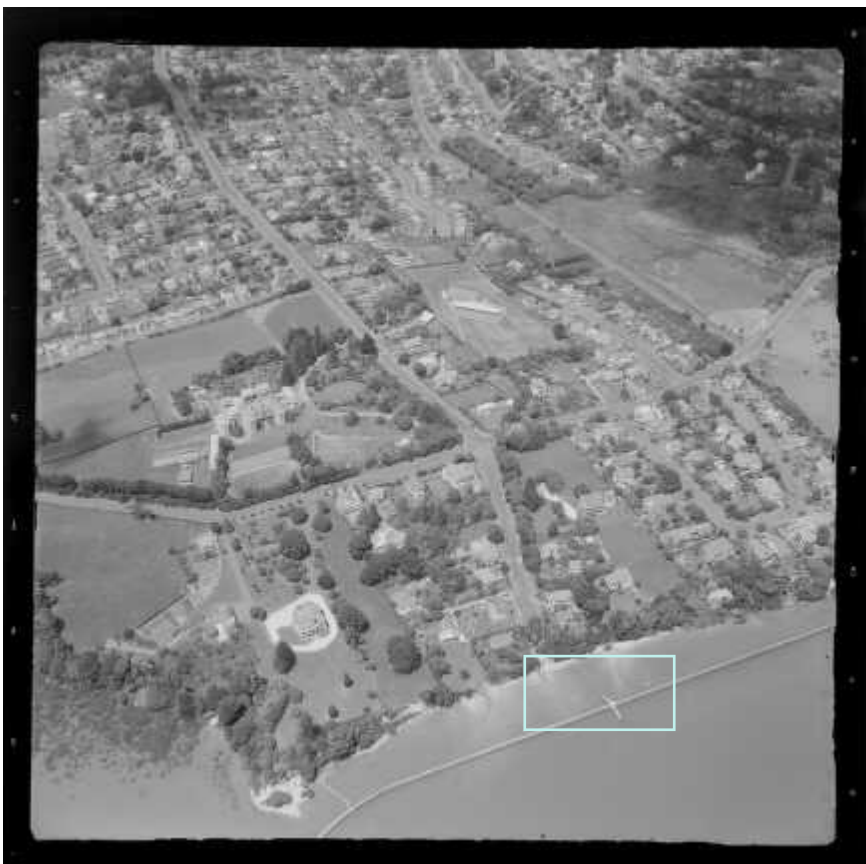
Oblique aerial view

Figure 8: Showing Hobson Bay, Victoria Avenue and Shore Road, Remuera (Whites Aviation Collection, Alexander Turnbull Library, PA-Group-00080: Whites Aviation Ltd: Photographs, Reference: WA-34082-F, 1953).

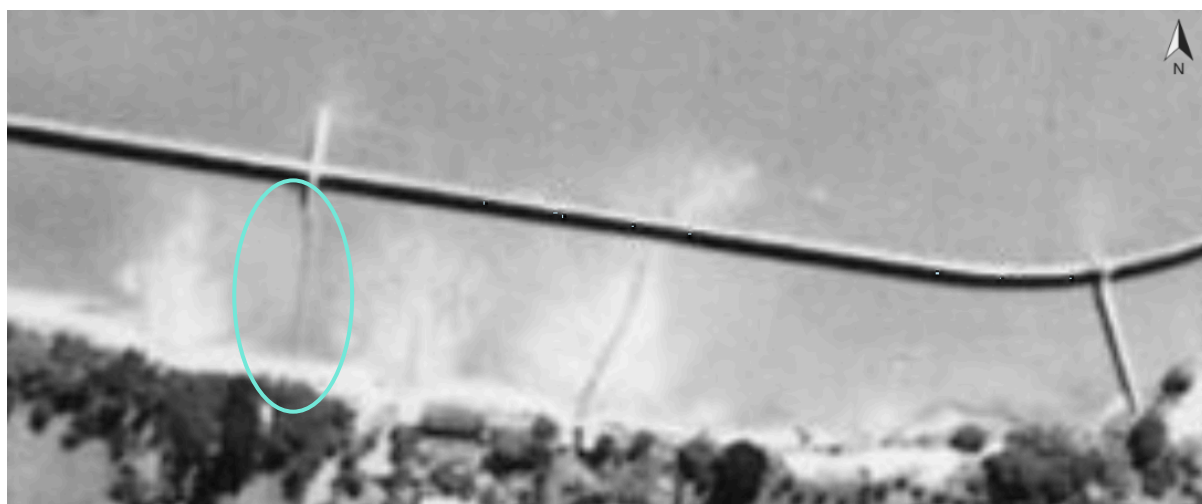
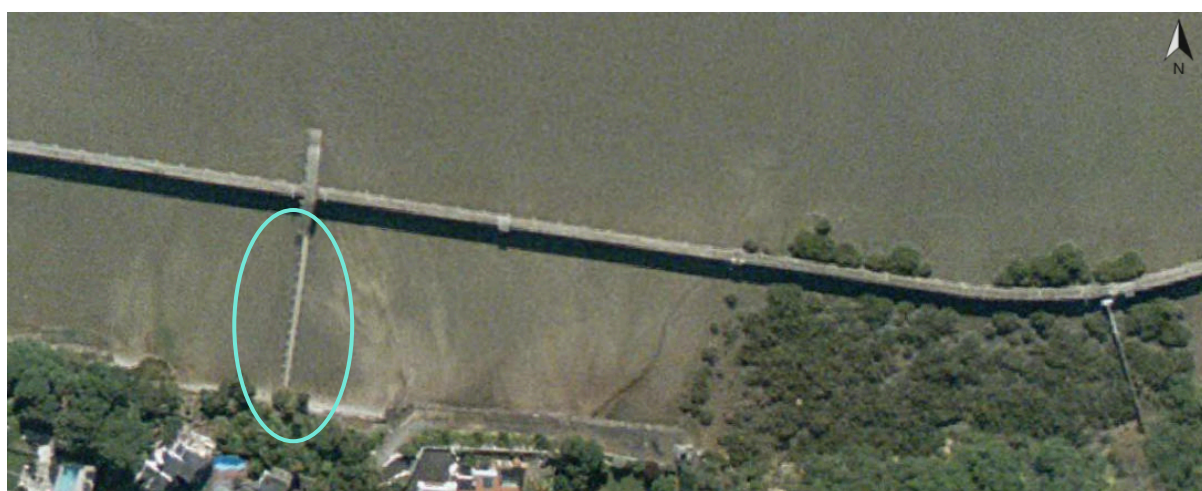
Figure 10: Series of aerial images (from top to bottom) 1940, 1959 and 2008 showing the Wilson's Beach Jetty (circled). Note in each of the images the jetty extends out into the bay and extends up and over the main sewer line (Auckland Council Geomaps).

The location and proportions of the jetty appear consistent in these early photographs and are similarly conveyed in a series of aerial photographs dating from 1940 (Appendix 1, Figures 10 and 11). However, in preparation of the demolition of the main sewer line, the northern portion of the jetty together with the access ramp that extended up and over the sewer, had been removed by 2010-2011. It is this shortened version of the jetty that exists today.

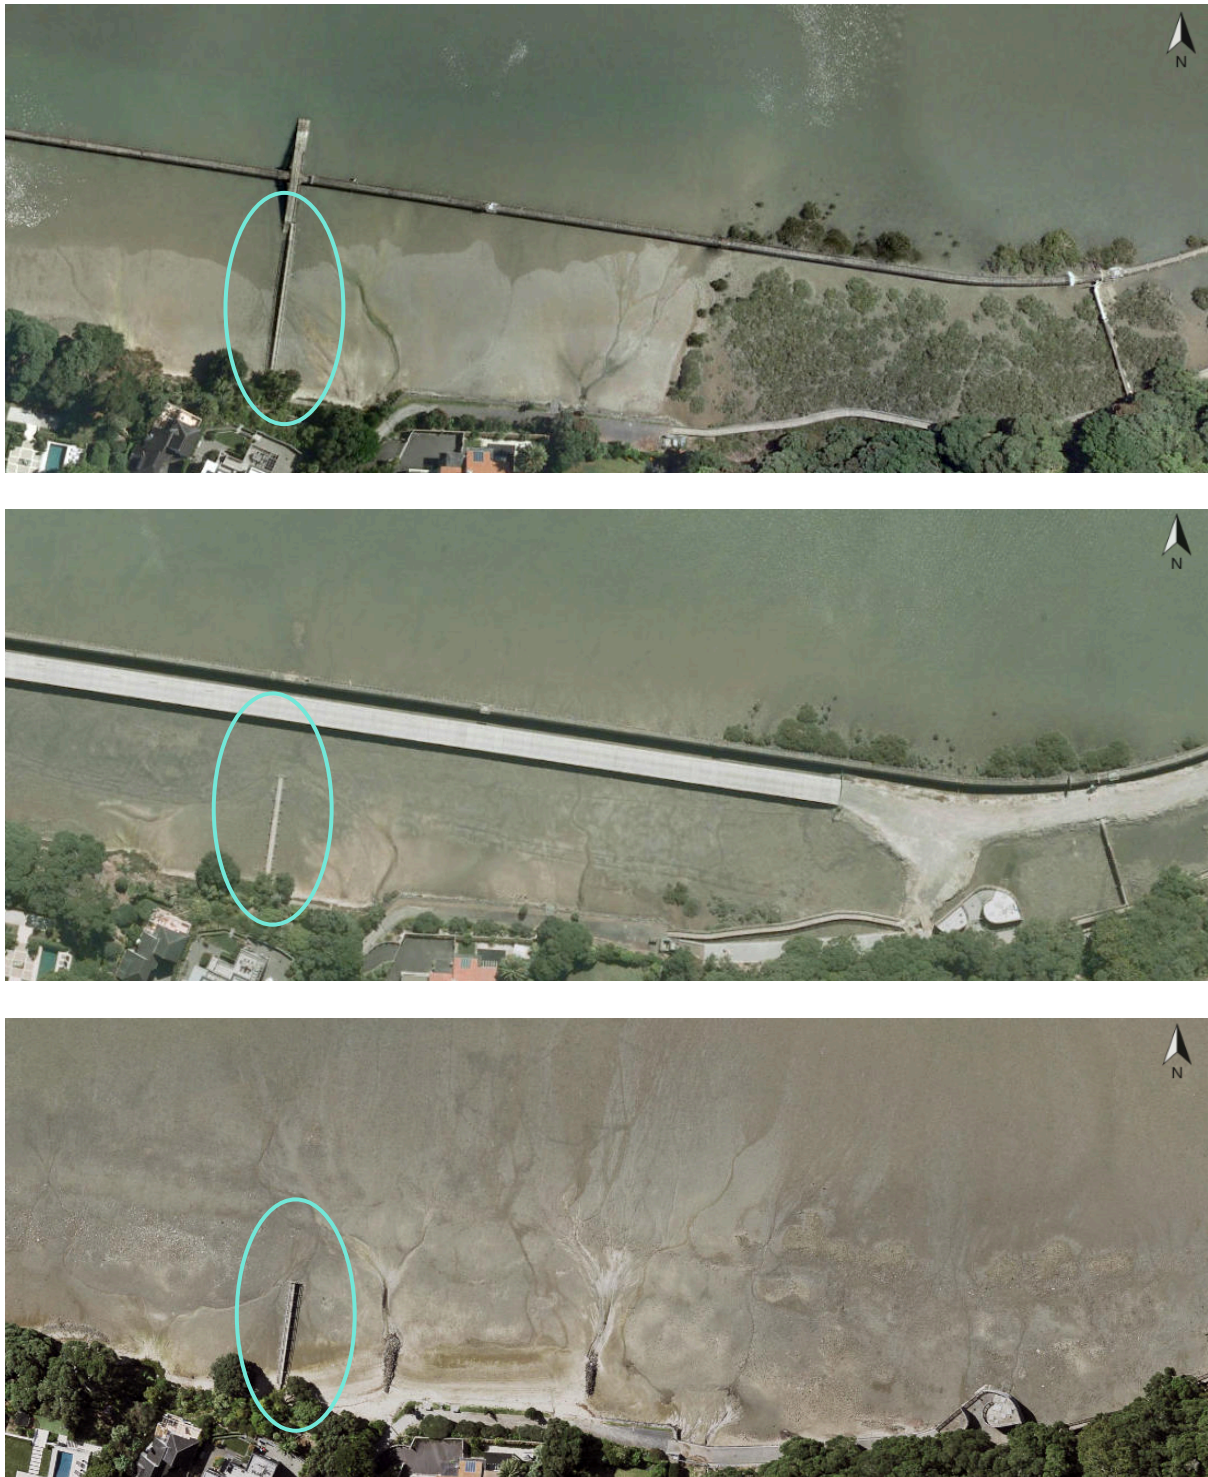
Figure 11: Series of aerial images (from top to bottom) 2008, 2010-11 and 2017 showing the Wilson's Beach Jetty (circled). Note in 2010-11, works have commenced with the removal of the main sewer line and shows that the extension over the line has been removed together with a section of the north end of the jetty. The 2017 image shows the jetty with no exposed sewer line (Auckland Council Geomaps).

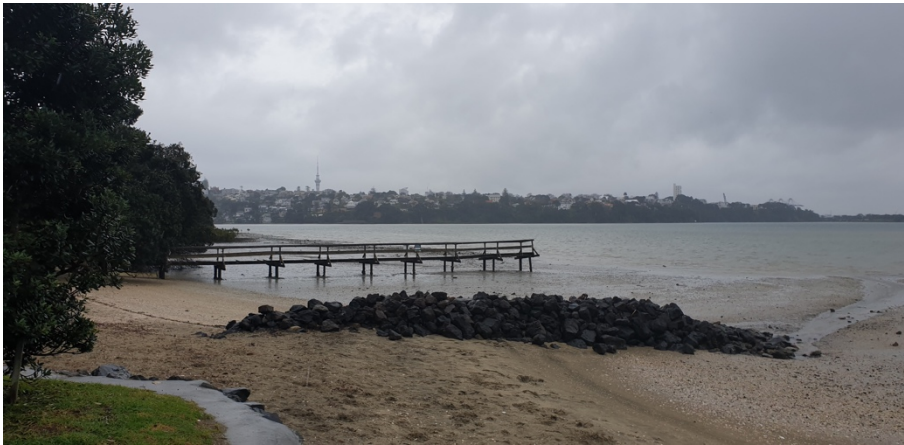
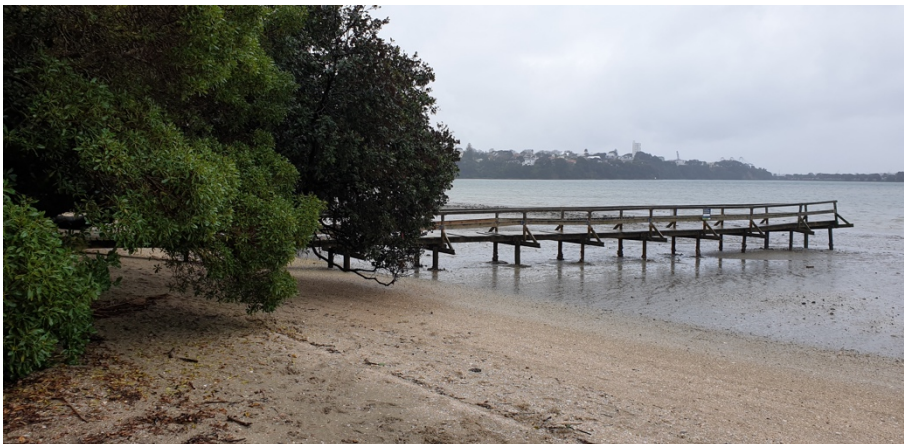
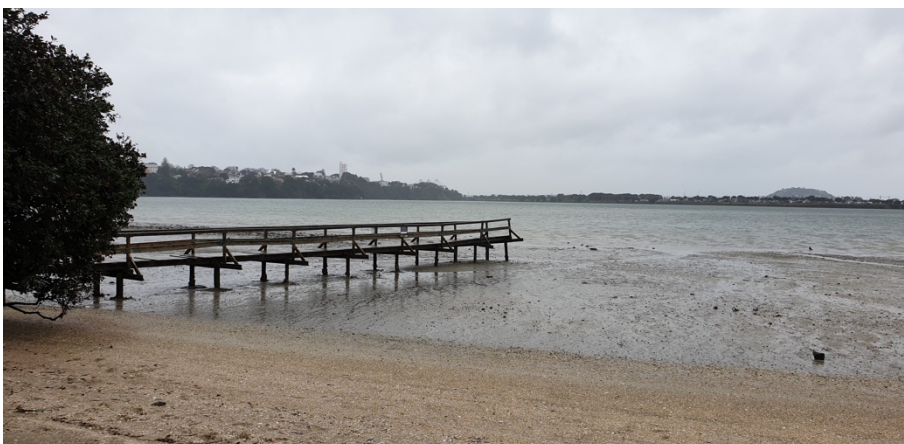
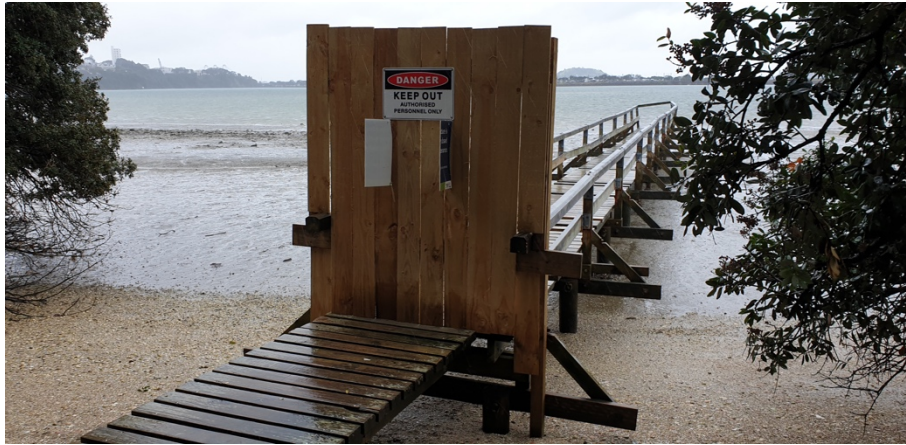
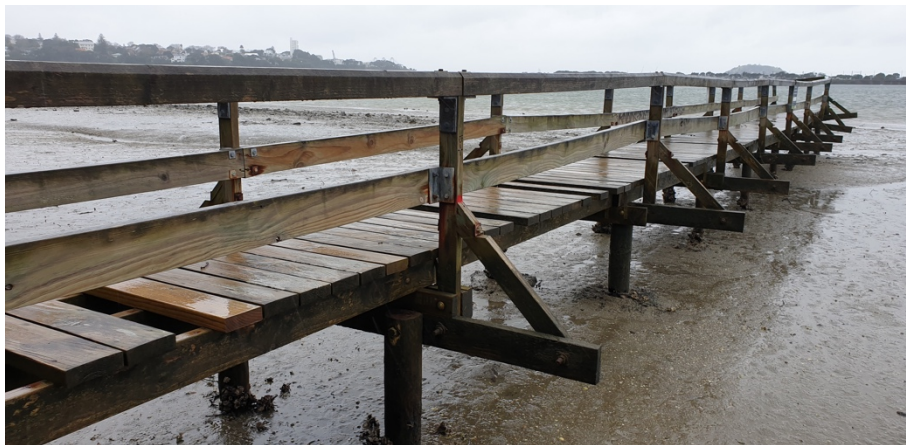
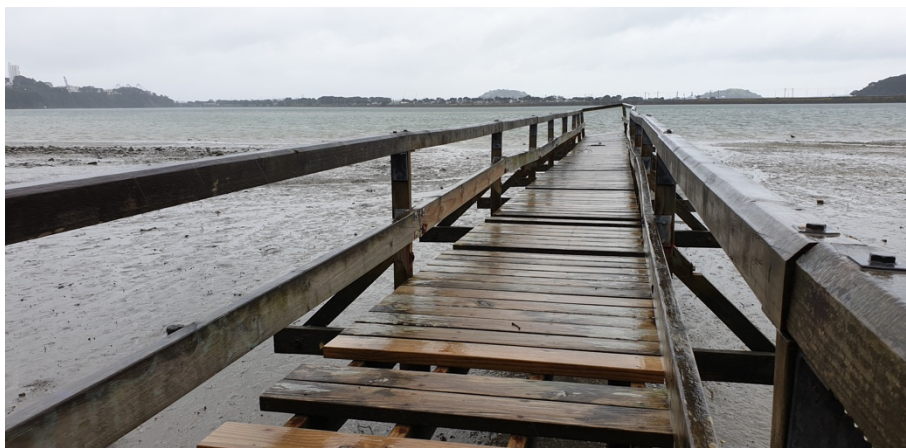
The following photographs were taken by the author on 12 July 2019.

When comparing the height and configuration of the present-day jetty with earlier images, it appears that the piles of the original structure were taller and more slender, suggesting that the supporting timbers were shortened or replaced. It is also apparent that additional handrails and supports have been added.

In such an exposed location, it can be expected that materials would have required replacing over the years, which, based on visual observations, appears to have been the case. Modern timbers and fixings are apparent, suggesting that much of the historic fabric has been replaced.
